# WET WALLS AND EFFLORESCENCE

*What efflorescence is and how  
to avoid it, with examples  
showing the results of neglect*

Results of two investigations conducted at the  
National Bureau of Standards, U. S. Department  
of Commerce, Washington, D. C., George K.  
Burgess, Director

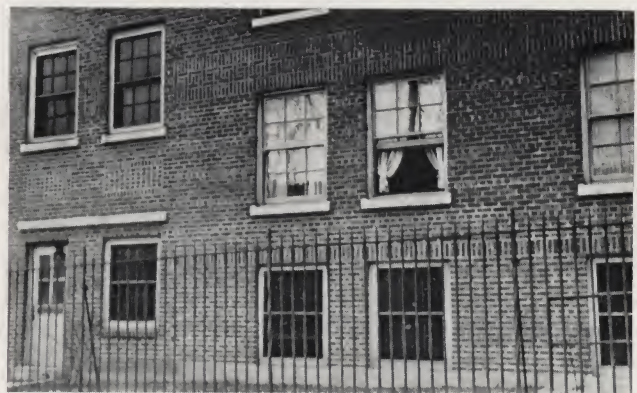
**FIGURE 26** illustrates protection against excessive water penetration at the sills. Note that each sill is a single unit and not two or three units with intervening vertical mortar joints. This illustration typifies the ideal drainage for sills. There are good drips underneath and an upward slope in each case from the window area toward the wall to left and right. The sills also project more than two inches. Good cornice and well pointed joints are

Figure 26. This illustrates good drainage for sills, with adequate drips and the proper slopes at the ends.

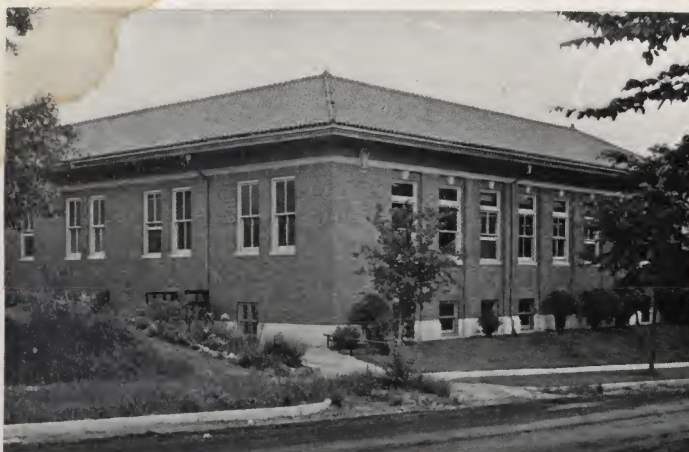
also characteristic features of this building. Another model of good design is illustrated by **FIGURE 27**. Here there are good drips on sills which are single units with no vertical joints. Other desirable features are the wide eaves, the cornice reentering, protection against seepage at the base by having the brick on stone some distance from the soil and the rain water leaders extending to the ground thus avoiding splashing.

Figure 27. This building illustrates good design as regards sills, wide eaves, cornice and protection at the base.

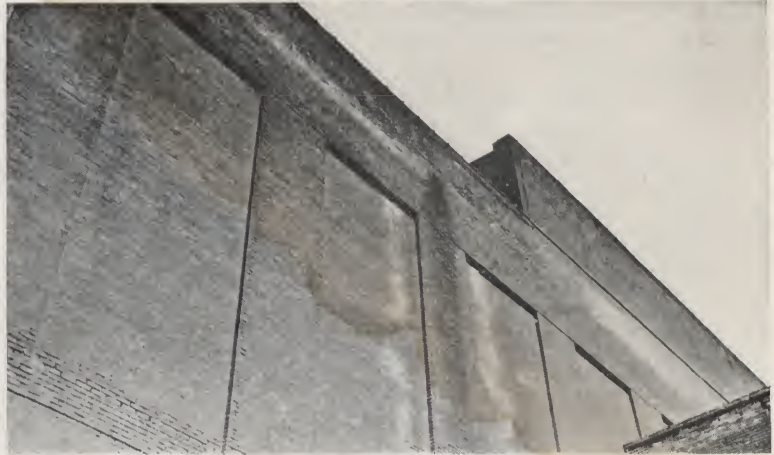
Again, to further illustrate combined faulty design, construction and maintenance, consider **FIGURES 35a, 35b, 35c and 35d**, all pictures of the same building although parts of an adjacent building are seen in **FIGURES 35a and 35c**. This was originally Condition B, without doubt. Kiln run common brick, a portion of which are underburned, compose the wall. **FIGURE 35d** shows the extent to which these brick as well as the intervening mortar joints near the soil have disintegrated. Efflorescence, very noticeable in the past, is becoming less noticeable at present while disintegration progresses. The walls have received quantities of water to wash out the salts for the most part. Galvanized iron which corrodes comparatively readily was used for flashing of the parapet wall which is about eight feet above the roof. There is both seepage and splashing, causing saturation of the lower wall. The coping is poorly designed. There are downspouts but these are inside the building and have undoubtedly become clogged. As a result, the overflow spouts have been called on to do the work with the results herein illustrated. As the joints progressively disintegrate the degree of saturation during a wet season increases. Below the wide recesses in the wall are projecting header courses of brick. It would be difficult to devise a more favorable condition for entrapping the maximum amount of moisture. Horizontal exposures are here unprotected by either sloping or by drips.

Figure 35a. This and the next three illustrations all show parts of the same building.

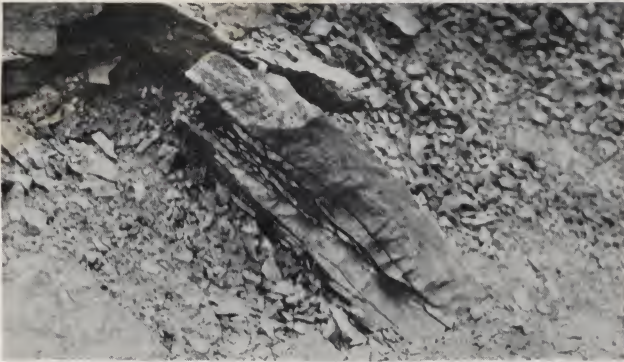
Figure 36b. Viewed close at hand, the destruction wrought by repeated freezing and thawing is seen to rival the power of dynamite.

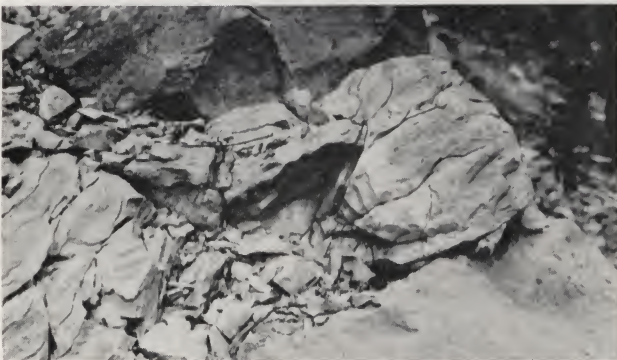
Figure 36c. Another type of rock broken up by frost action.

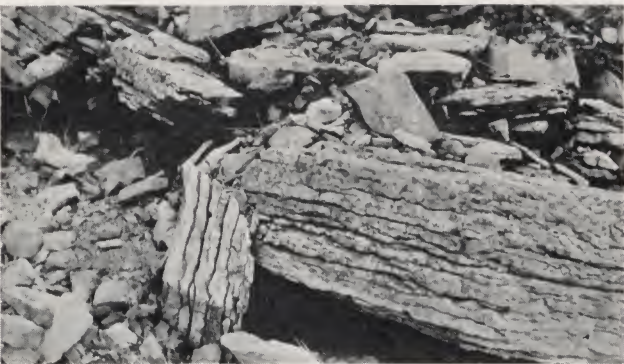
Figure 36d. Still another variety disintegrated by frost.

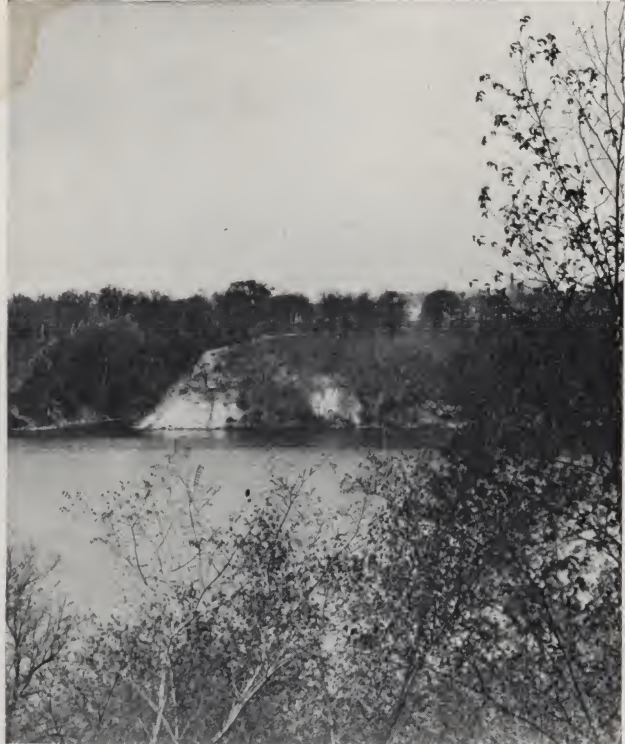
Some consideration might also be given finally to the analogous weathering of rock in nature. In connection with the following illustrations, one might make the appropriate statement: "Nature destroys her own." In **FIGURE 36a** can be seen in the distance across the river, the result of frost action, supplemented by erosion by water and wind. **FIGURES 36b, 36c, and 36d** give one some notion as to the tremendous forces brought to bear in repeated freezing and thawing. Dynamite could hardly do more. These stones, of course, had no drips. The sandstone base illustrated in **FIGURE 37** is almost as much at the mercy of the elements. **FIGURE 38** shows a bridge railing without drip or enough slope. One might go on indefinitely, but it is hoped that the preceding illustrations show that there is required today more consideration of the subject, water penetration, in the building industry. Reduce water penetration and efflorescence will diminish in any case, whether there is a great deal of soluble

Figure 36a. Talus slopes such as this are common sights below cliffs of solid rock, along shore lines everywhere, for frost action is a relentless force, initiating the process of disintegration and opening the way for erosion by water and wind.
